Ultramark 4

ULTRASOUND SYSTEM

field service manual

Service Manual 4730-0001-06 Rev B consists of:

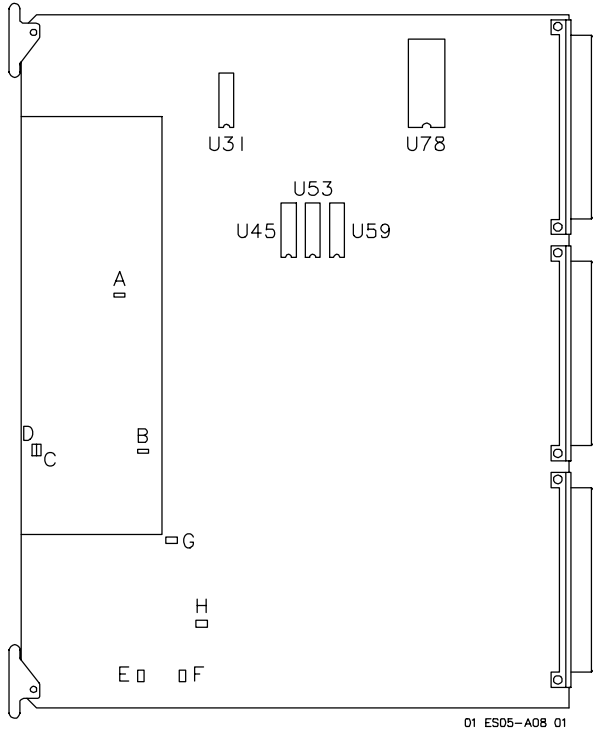
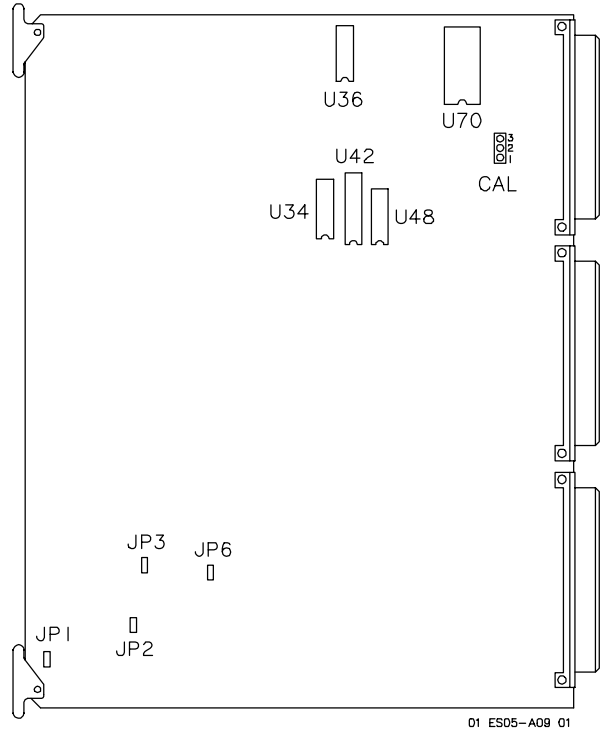
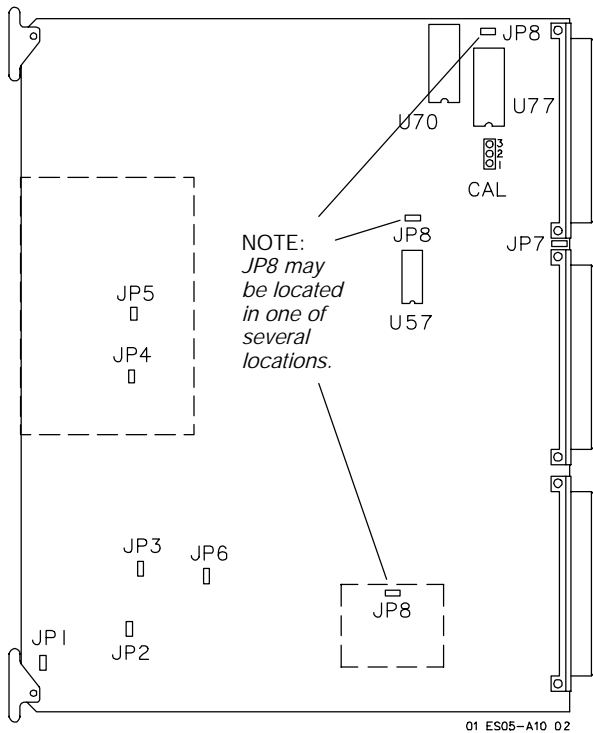
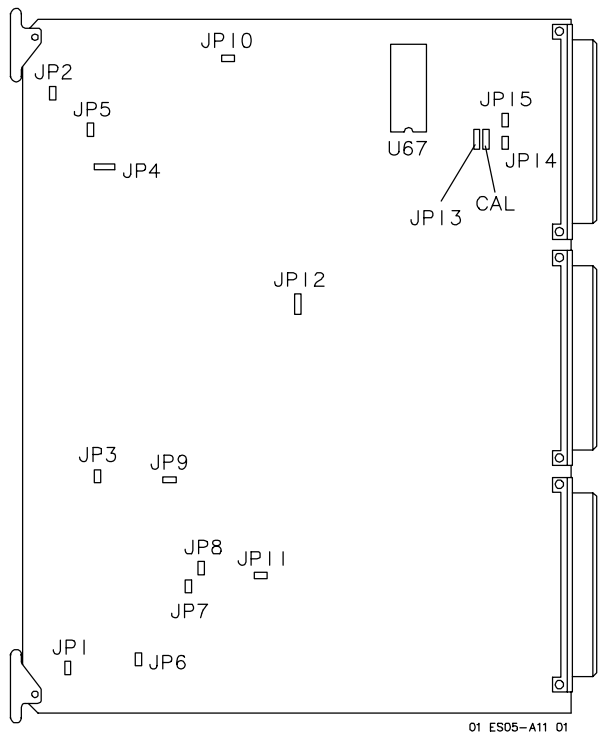
PCB		JUMPER OR SWITCH				
Part No.	Dash No.	Ref. Des.	Pins	Function	Normal Position	Notes
7500-0370	ALL	JP1	1-2	N/A	Shorted	
		JP2	1-2	N/A	Shorted	
		JP3	1-2	N/A	Shorted	
	XX	JP4	1-2	N/A	Shorted	
		JP5	1-2	N/A	Shorted	
7500-0370	ALL	JP6	1-2	N/A	Shorted	
		CAL	1-2	N/A	Shorted	
		JP7	1-2	Shorted for Doppler Sync; Open for Non-Doppler Sync; Open for Non-Sync, Non-Doppler	Hardware dependent	Refer to Up/Down Rev Instructions
		JP8	1-2	Open for Doppler Sync; Shorted for Non-Doppler Sync; Open for Non-Sync, Non-Doppler	Hardware dependent	Refer to Up/Down Rev Instructions
3500-1261-01 (Dop) ¹ 3500-1262-01 (Non-Dop) ¹	ALL	JP1-JP 13	1-2		Shorted	
		JP-14	1-2	Doppler Non-Doppler	Open Shorted	Sync configuration
		JP-15	1-2	Doppler Non-Doppler	Shorted Open	Sync configuration
		CAL	2-3		Shorted

**PULSE PROCESSOR (A5)
7500-0313 (S1 ONLY)**

**PULSE PROCESSOR (A5)
7500-0370**

**PULSE PROCESSOR (A5)
7500-0370-XX**

**PULSE PROCESSOR (A5)
3500-1261/62-XX
(7500-0561-XX Plus Configuration)**

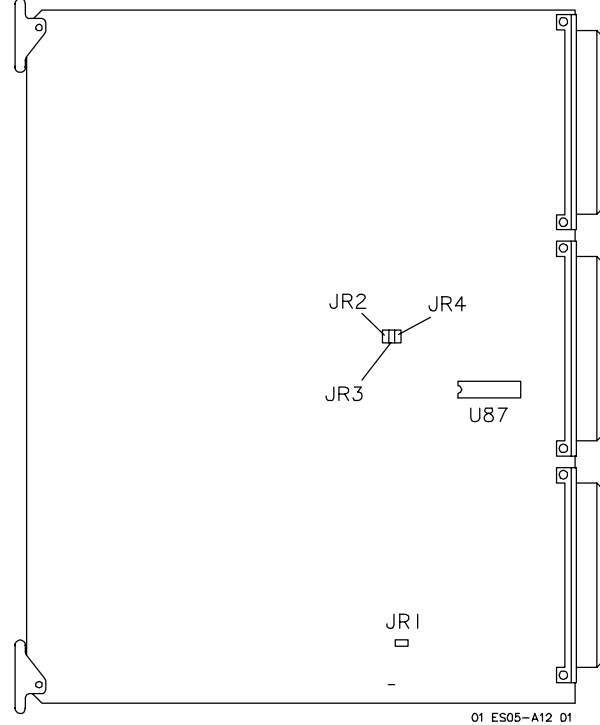
DOPPLER ACQUISITION PCB (A6)
7500-0346-XX

NOTE: There are no PROMs for the Doppler Acquisition PCB.

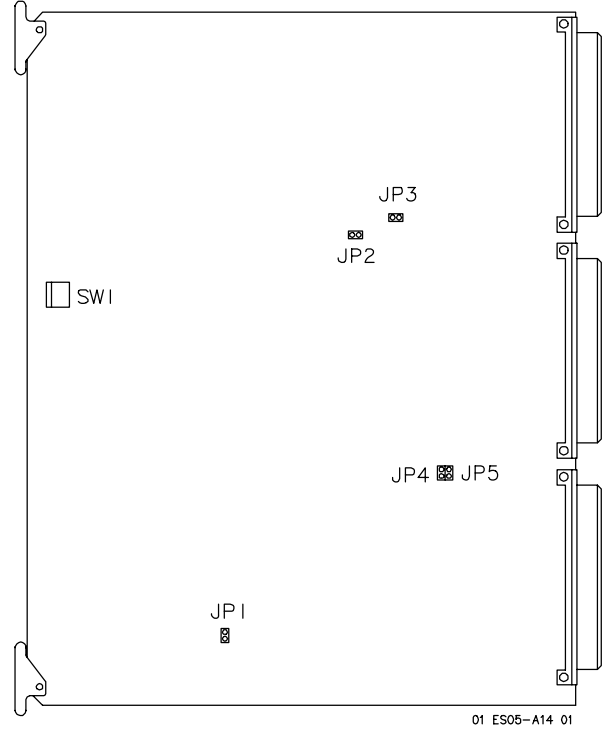
PCB		JUMPER OR SWITCH				
Part No.	Dash No.	Ref. Des.	Pins	Function	Normal Position	Notes
7500-0347	ALL	JP1	1-2	Shorted for 8K x 8 RAM	Shorted	
		JP2	1-2	Shorted for 32K x 8 RAM	Open	
		JP3	1-2	Shorted for 16K x 8 RAM	Shorted	
		JP4	1-2	Shorted for 16K x 8 RAM	Open	
		JP5-JP14	1-2	Not used	Open	Not illustrated because not movable.
		SW1	1	Not used	N/A	
			2	Not used	N/A	
			3	Not used	N/A	
			4	Not used	N/A	
7500-0390	ALL	JP1	1-2	Test	Shorted	
		JP2	1-2	Memory expand	Open	
		JP3	1-2	Disable Sync clock	Shorted	
		JP4	1-2	Memory expand	Open	
		JP5	1-2	Memory expand	Shorted	
		SW1	1	Not used	N/A	
			2	Not used	N/A	
			3	Not used	N/A	
			4	Not used	N/A

DOPPLER PROCESSOR (A7)
7500-0347-XX

DOPPLER PROCESSOR (A7)
7500-0390-XX

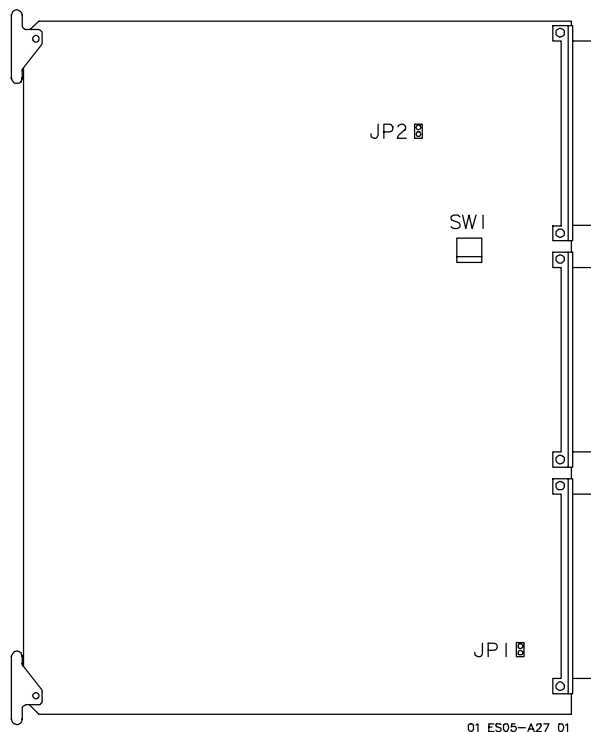
**S. C. Combo and Cine PCBs (A9)
 7500-0778-XX; 7500-0798-XX**

NOTE: Do not order 7500-0778 or 7500-0798 PCBs. Jumper information is for configuration reference only. Order the appropriate 3500 assembly to assure receiving a PCB properly configured and adjusted for the specific application.

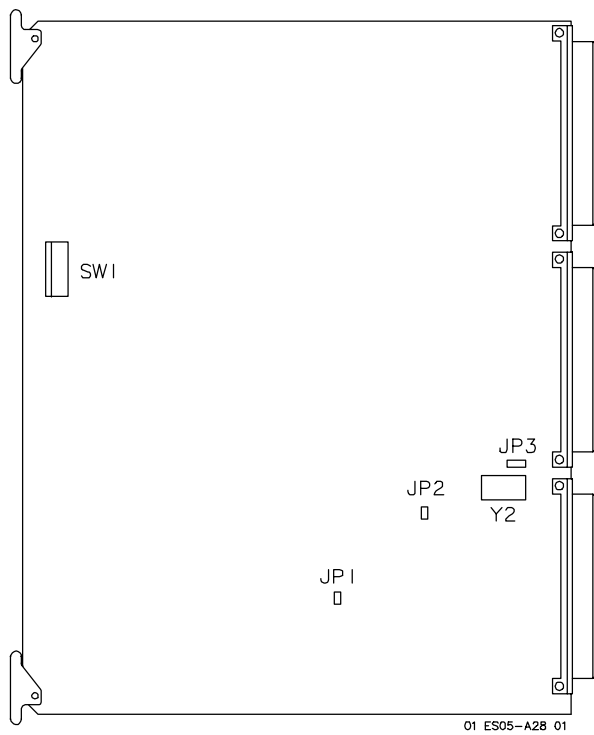
DISPLAY CONTROLLER PCB (A14)
7500-0300-30 & up

1. Do not order 7500-0300-30 or higher PCBs or 7500-0827-XX PCBs. Jumper information is for configuration reference only, order the appropriate 3500 assembly to assure receiving a PCB properly configured and adjusted for the specific application.

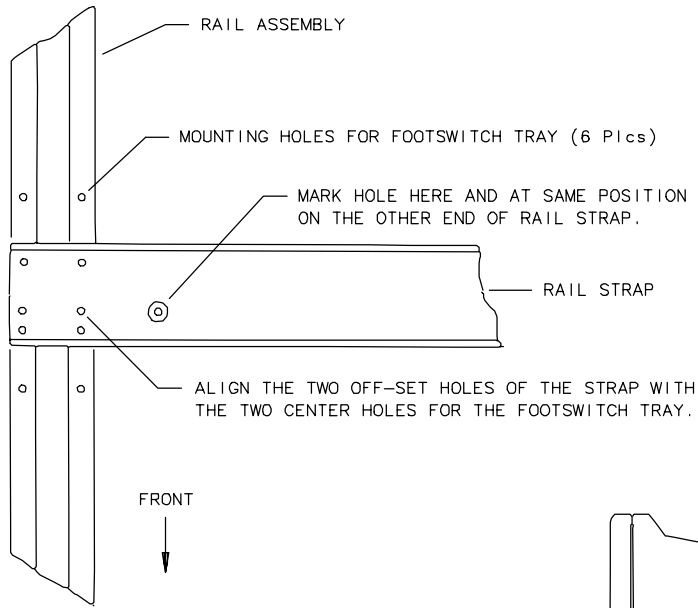
Figure 1. Bottom View of HFC

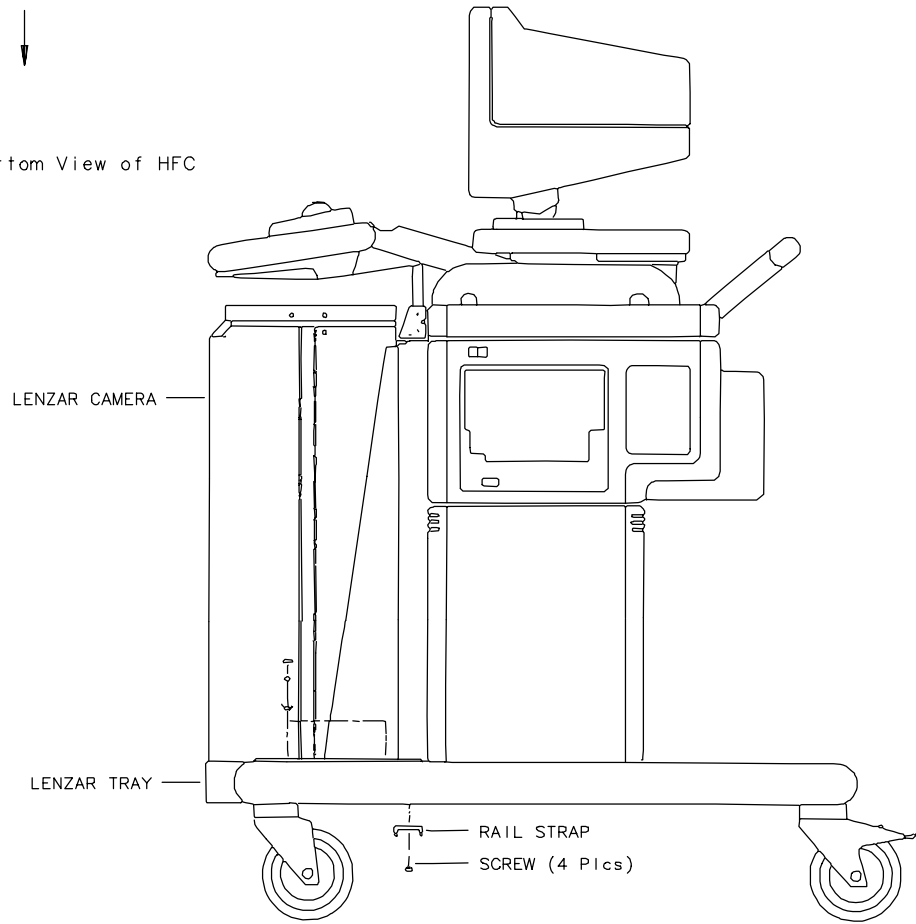
Figure 2. Side View of HFC

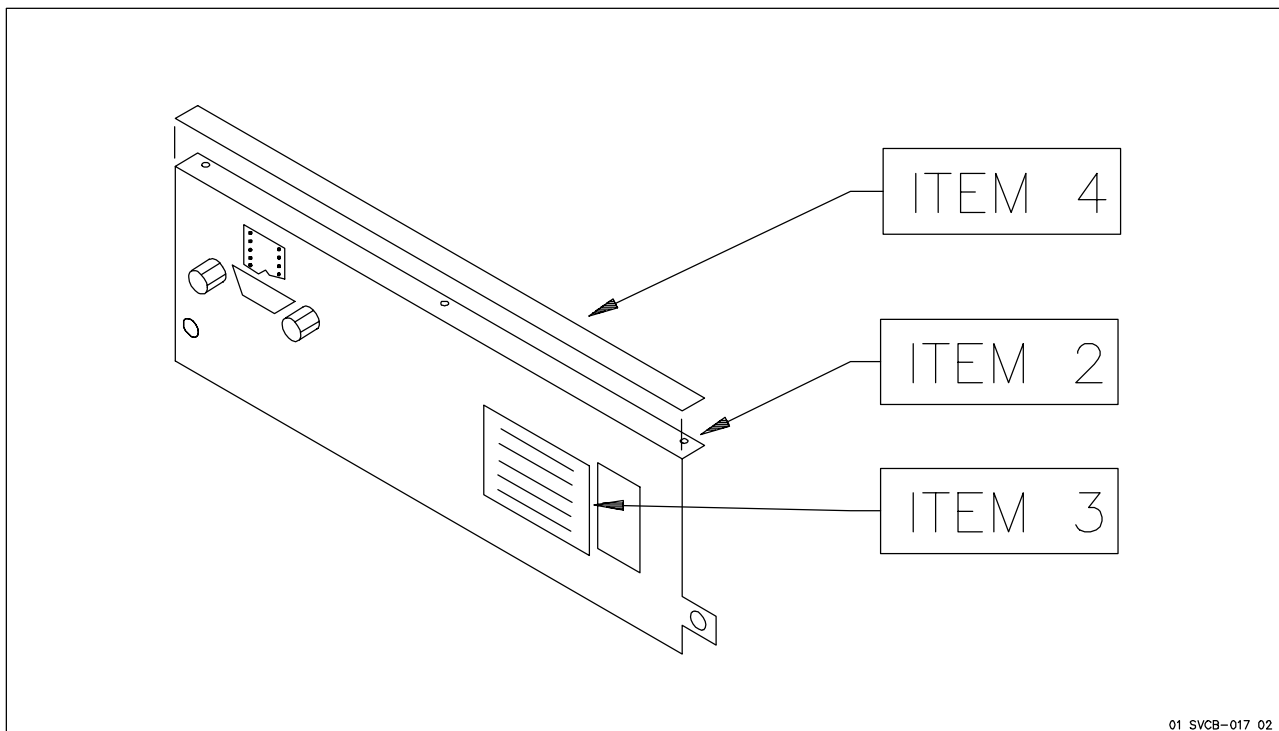
Figure 2.

- PROCEDURE:**
6. Turn off power.
 7. Remove Rear Panel (Item 2 in Figure 2).
 8. Inspect the Power Distribution Assembly
 - If fuses continue to blow or there is evidence of melting or overheating, replace the Power Distribution Panel with appropriate replacement in the table above. Continue with step 4.
 - If the Power Distribution Assembly is either a 3500-1094-04, 3500-1095-03, or 3500-1096-04 or if the Power Distribution Assembly is a 3500-1463, 3500-1468, or 3500-1469, no further action is required and the system can be reassembled.
 9. Remove Power Distribution Assembly.
 10. Install replacement Power Distribution Assembly (Item 1 in Figure 1).
 11. Attach Item 3 and Item 4 to replacement rear panel (Item 2 in Figure 2).
 12. Install Rear Panel.
 13. Power up system.
 14. Complete service documentation indicating parts replaced.
 15. Return material to ATL for disposition.

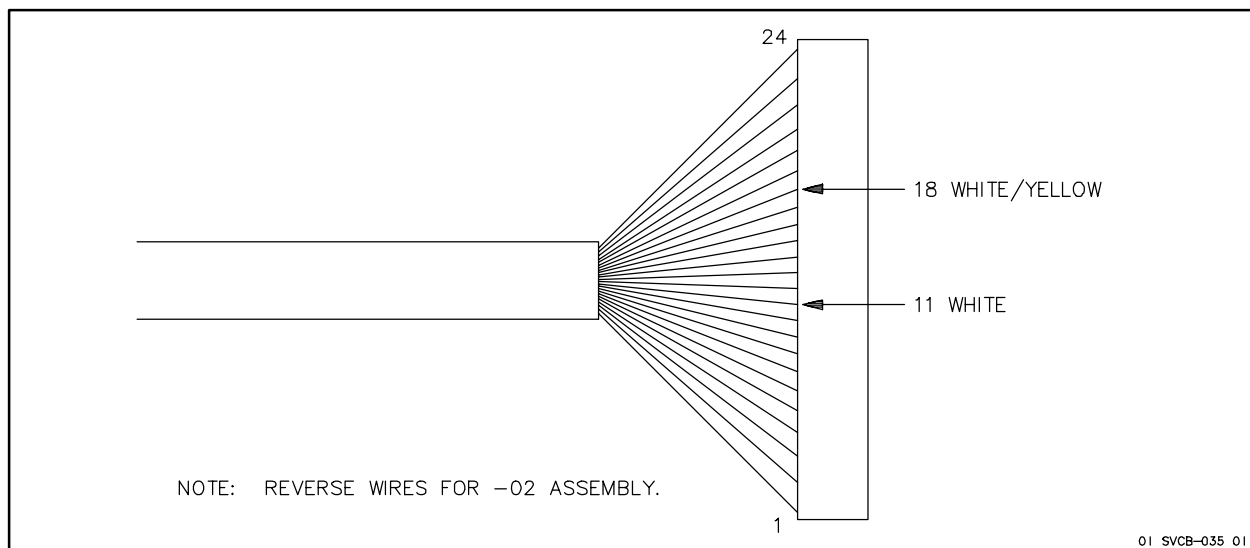
- NOTE:** *If you have a 3500-0674-01 cable, the conversion to a -02 can be done in the field.*
- EFFECTIVITY:** Holding the connector with the wires to the left, count up to pin 11 (solid white wire). Extract the wire from the connector and continue to pin 18 (white and yellow striped wire). Extract the wire from the connector, move the white and yellow wire to pin 11 and the white wire to pin 18. Swap the wires on one side of the cable only. Mark the cable 3500-0674-02.

Figure 1. Cable Assembly, Dual Access to Motherboard, P/N 3500-0674-01

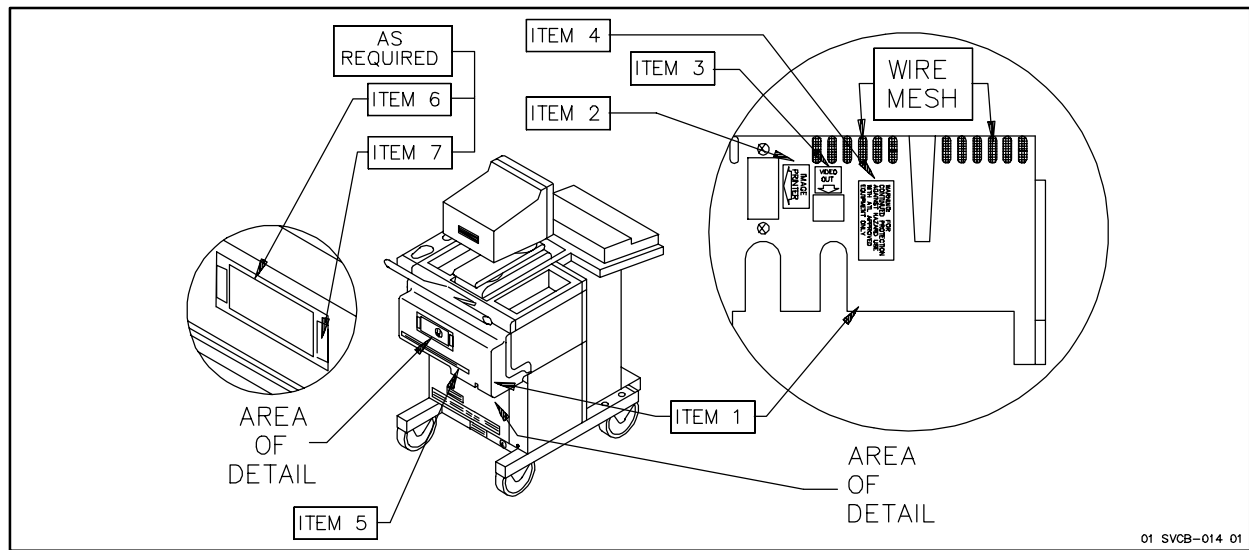
Figure 1

- PROBLEM:** Wire mesh missing from cooling slots on lower right of cover (reference Figure 1, below). The presence of the mesh is required to meet UL specifications.
- CAUSE:** Vendor error during manufacturing of cover.
- EFFECTIVITY:** HFC UM-4 systems shipped on or after March 1, 1992 but before June 29, 1992. Systems shipped during this time may or may not have the wire mesh.
- SOLUTION:** On a next-call or next-PM basis (whichever comes first), verify wire mesh is present. If it is, no action is required. If it is not, order the following part numbers and replace upon receipt of parts:

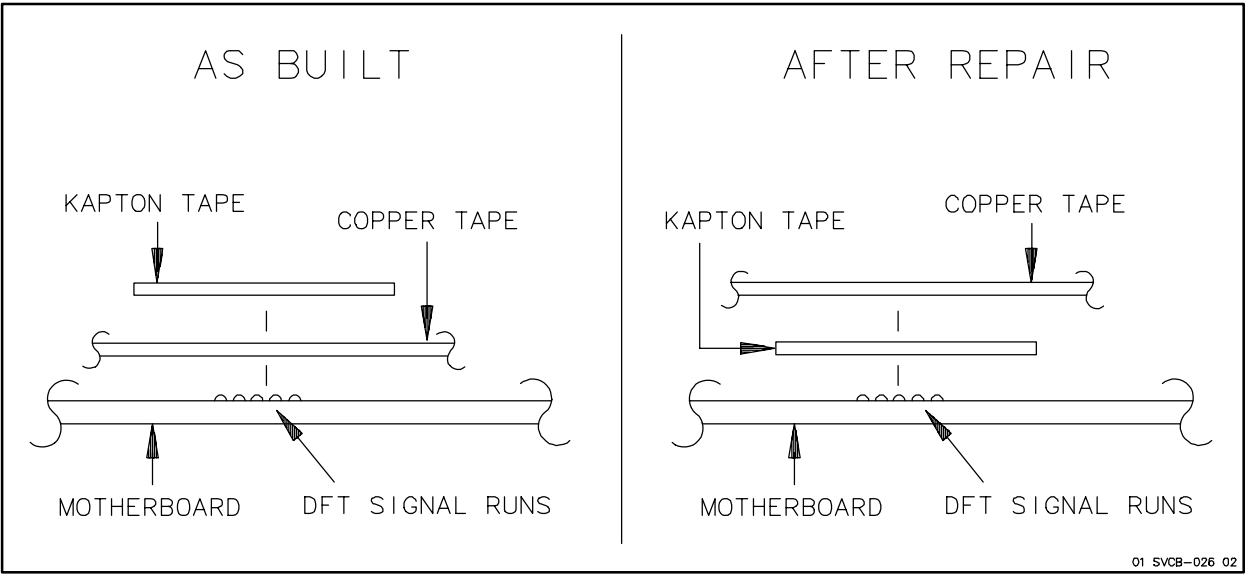
Problem/Symptom	Possible Cause	Solution
Dropouts in linear image that cannot be traced to a PCB, scanhead, cables or the DFT connector.	DFT signals are being shorted to ground at the junction of the Motherboard and the E.M. chassis. Refer to figure below: The Motherboard Vendor built the PCB incorrectly as follows: Kapton (insulating) tape was placed on top of, rather than under, the copper tape. The copper tape enhances the ground (GND) connection between the Motherboard and the E.M. chassis. The Kapton tape is intended to insulate DFT signal runs (lands) on the Motherboard from the copper tape (GND).	Repair the Motherboard on the next PM, next call, or upon failure. Domestic (U.S.) Customer Support Representatives (CSRs) who have affected UM-4 HFC systems in their area will receive the necessary parts to complete the rework (ATL P/N 8000/8055- 0837-01). International personnel need to order ATL part number 8000-0837-01. Estimated time for repair will be less than replacing the chassis or Motherboard.

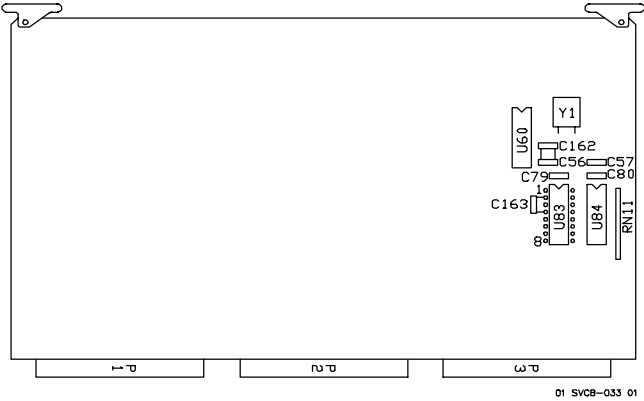
Problem/Symptom	Possible Cause	Solution
<p>Incomplete rework causes inaccurate measurements</p> <p>Scope: All 2D Scan Converter Interface PCBs Domestic part numbers: 7500-0273-02, 04, 06, 08, 10, 60 International part numbers: 7500-0273-03, 05, 07, 09, 11, 61</p> <p>Effectivity: Next PM or next call basis.</p>	<p>Incomplete rework on the 2D Scan Converter PCB.</p>	<p>Inspect the 2D Scan Converter Interface PCB for the completion of the rework.</p> <ol style="list-style-type: none"> Check the fabrication number of the PCB. <ol style="list-style-type: none"> If the fabrication number is 2500-0273 Rev B, continue with the procedure. If the fabrication number is not 2500-0273 Rev B, mark the FSR as inspection complete. <p>NOTE: <i>Fab number can be found on the solder side of the PCB on the top left corner.</i></p> <ol style="list-style-type: none"> Verify C162 (0.1 UF P/N 3725-0003) is attached to C56 (see figure below). Verify C163 (270 PF P/N 3725-0039) is attached to U83 pin 2 and U83 pin 4 (see figure below). Replace PCB if either of the capacitors is missing. Complete FSR, indicate verification of rework for the 2D Scan Converter Interface.

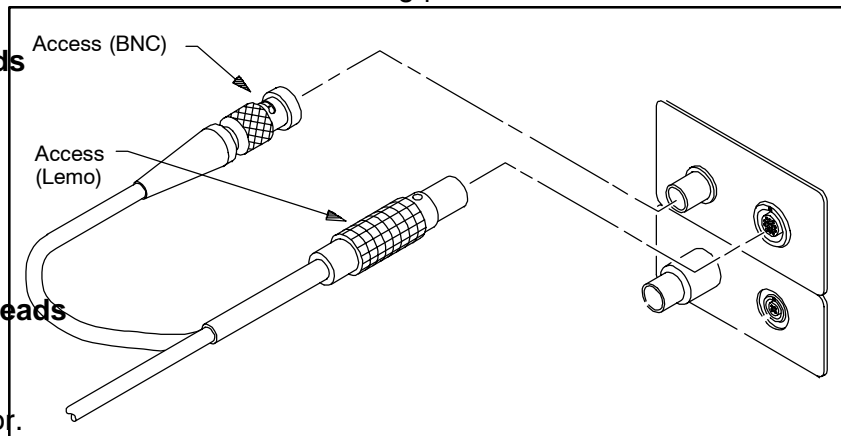
- 1.. Freeze system.
- 2.. Disconnect Lemo connector.
- 3.. Disconnect BNC connector.

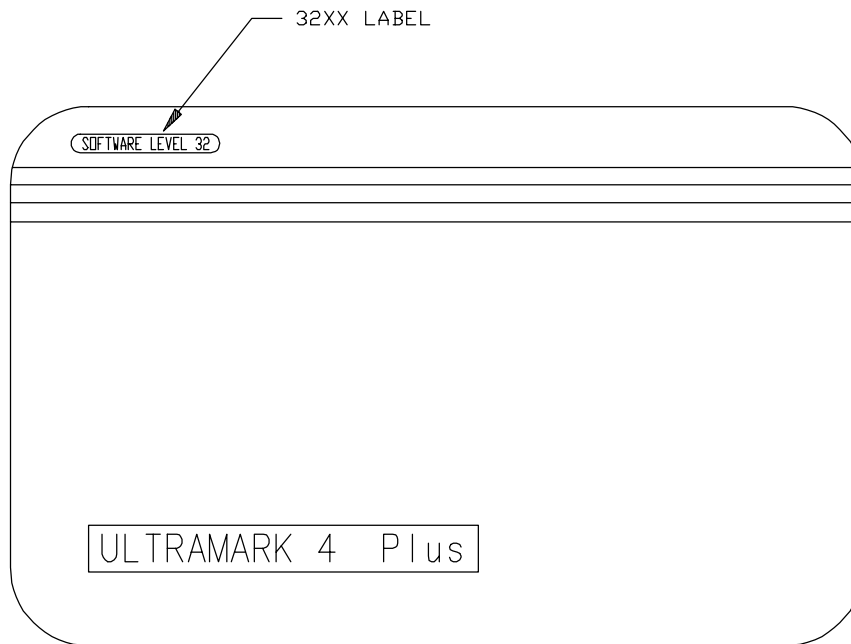
SOLUTION: To help the user identify this software level of the UM-4, a label has been installed on the front cover of all new build UM-4 systems. This label, part number 4100-0929-01 for English, 4100-0930-01 for French, and 4100-0931-01 for German, needs to be positioned on the top left corner of the front cover, P/N 1064-0223-01, when you perform a software upgrade in the field. In the event this cover is replaced due to damage, this label must to be installed on the replacement cover.

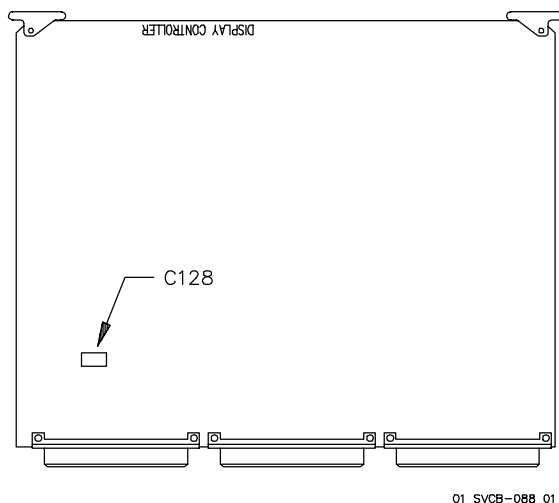
Figure 1

SOLUTION: Replace PCB only if noise appears in video display and capacitor has been verified to be reversed (same polarity as silk screen—see Figure 1). A new fabrication will be released to correct the artwork.

CAUSE: The silk screen on the PCB fab is backwards from what the actual orientation is for C128. The automated surface mount machine places the part in the correct orientation but it is believed that operators later in the build process might change the capacitor to match the polarity marking on the PCB.

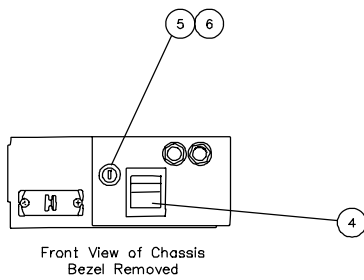
Figure 8-7. A/V Module

Front View of Chassis
Bezel Removed

Fig. No./ Index	ATL Part No.	Description	Notes
8–7			
	4000-0143-xx	Audio/Video Module	
NOTE: The 4000-0144-10 (with switch) and the -12 (without switch) are not interchangeable. Refer to the Replacement Matrix for correct replacement part numbers.			
1		Chassis, A/V Module	
2		Binding Post, Metal, 6–32	
3		Line Filter, 6A, 120/250 VAC	
4		Rocker Switch, DPST, 16A, 250 VAC	
5		Fuseholder, 5x20 mm, Panel Mount	
6	2700-0066	Fuse, 800 mA, Extra Slo Blo, 250V	120 V
	2700-0064	Fuse, 400 mA, Extra Slo Blo, 250V	240 V
7		Fuse Block, 10–5x2	
8	2700-0066	Fuse, 800 mA, Extra Slo Blo, 250V	
9	2700-0061	Fuse, 5A, Slo Blo, 250 V	
10		Transformer	
11		PCB, Motherboard	
12		PCB, Power Supply	
13		Bezel	
14		Cover, Enclosure	
15		Insulator, Cover	
16		Plate, Mounting	
17		PCB, Stereo Interface	
18		PCB, Digital Interface	
18		PCB, VCR Interface	Repl Dig. Interface PCB

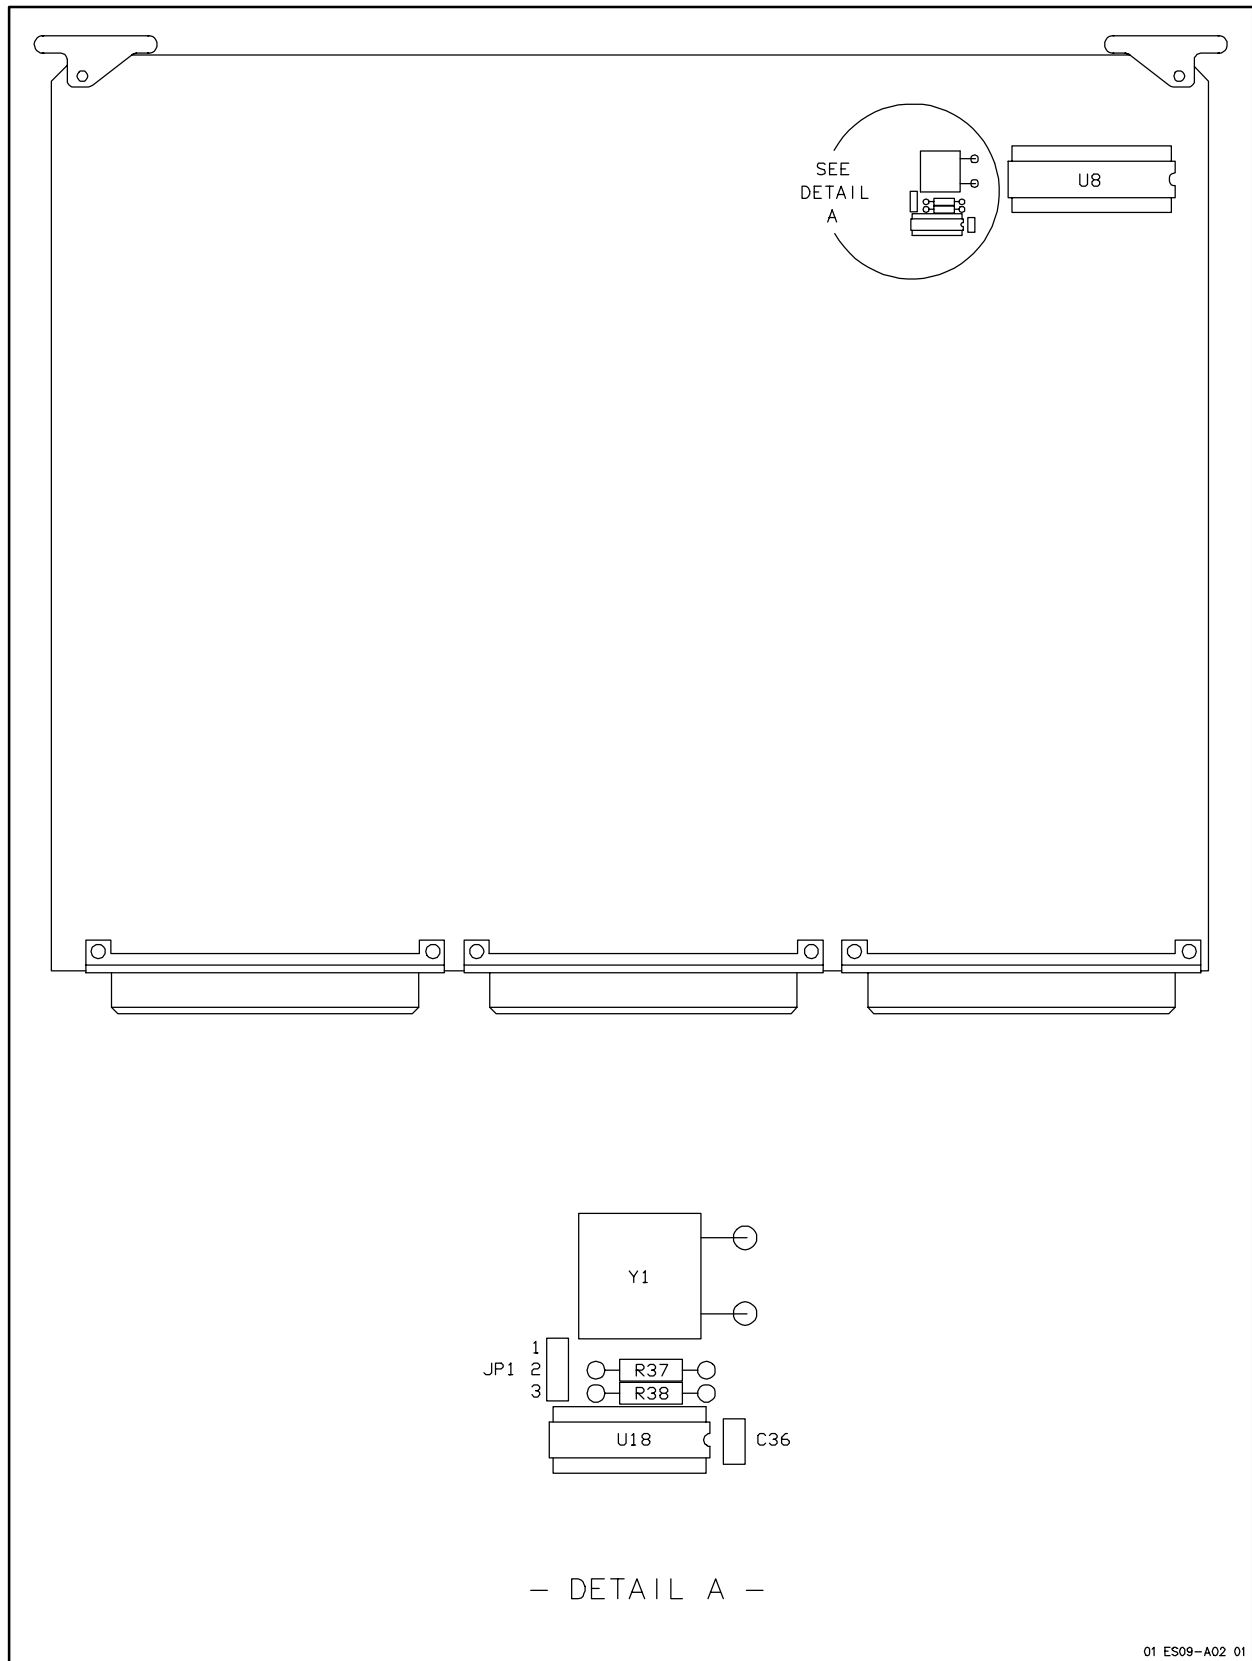
Figure IA. 7500-0348-10/08 PCB

1. Install a 1K OHM resistor, 2831-0013, at the R37 location (see Figure IA).
2. Change U18 to a 74F04 IC, 2035-0140. (Preserve any lifted pins and jumpers)
3. Move the jumper connector at Pins 2 and 3 of JP1 to Pins 1 and 2 of JP1.
4. Using 4100-0092 label or any available small blank stick-on label, mark the board as "Non Sync" near the dash panel indicator.

COMMENTS: This change renders the PCB as a Non-Sync type with its own independent clock.

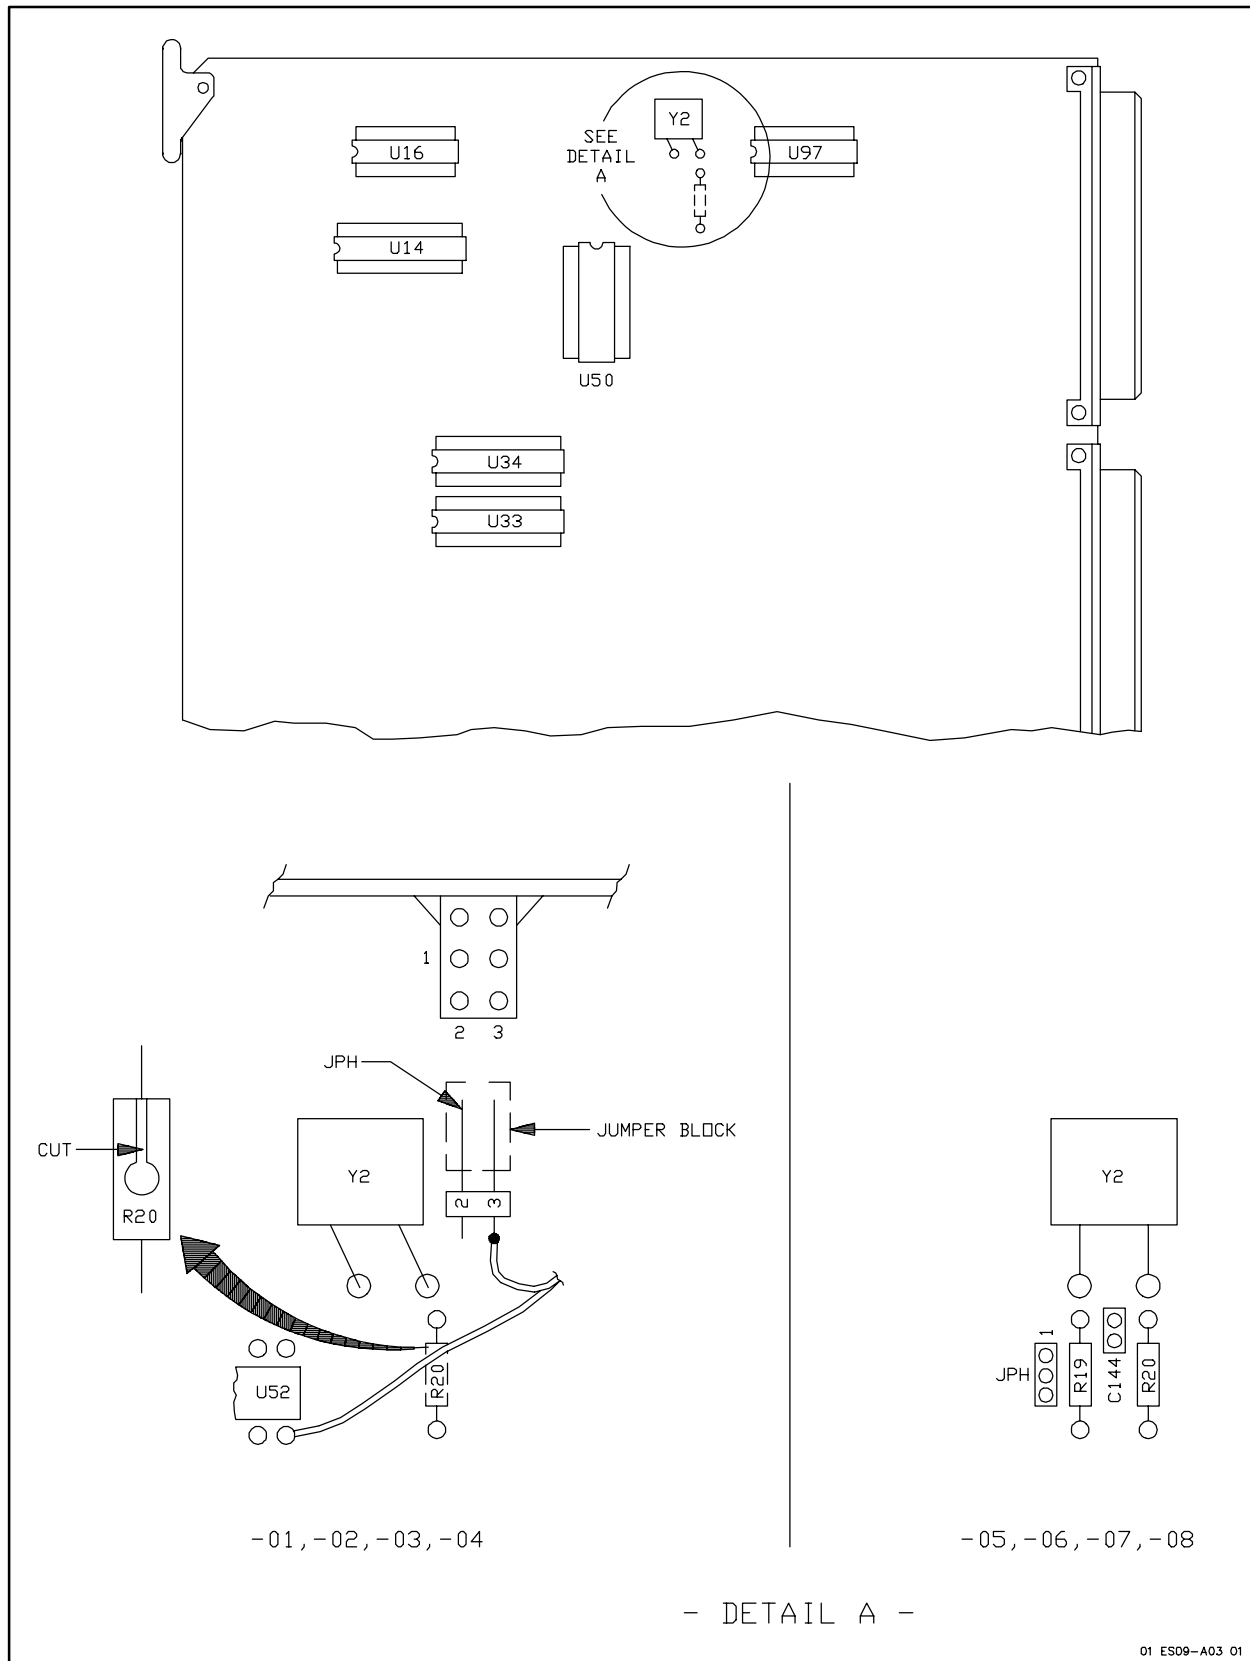
Figure II. 7500-0362-08/07/06/05/04/03/02/01 PCB

1. Move the wire that comes from the JPH-1 to the right solder post of R20 if it is on the left solder post. (See [Figure II](#))
2. Cut the run to the pad directly underneath the R20 body (underneath and hidden by the body of the resistor as one looks directly down on the PCB; this run and pad are within the silkscreen for the R20 resistor body) on the component side.
3. Install a 1K OHM resistor, 2831-0013, at R20 location.
4. Change U52 to a 74F04 IC, 2035-0140. (Preserve any lifted pins and jumpers)
5. Move jumper connector at Pins 2 and 3 of JPH to Pins 1 and 2 of JPH.
6. Using 4100-0092 label or any available small blank stick-on label, mark the board as "Non Sync" near the dash level indicator.

COMMENTS: This change renders the board as a Non-Sync type with its own independent clock. Steps 1 and 2 of the instructions above correct a build error.

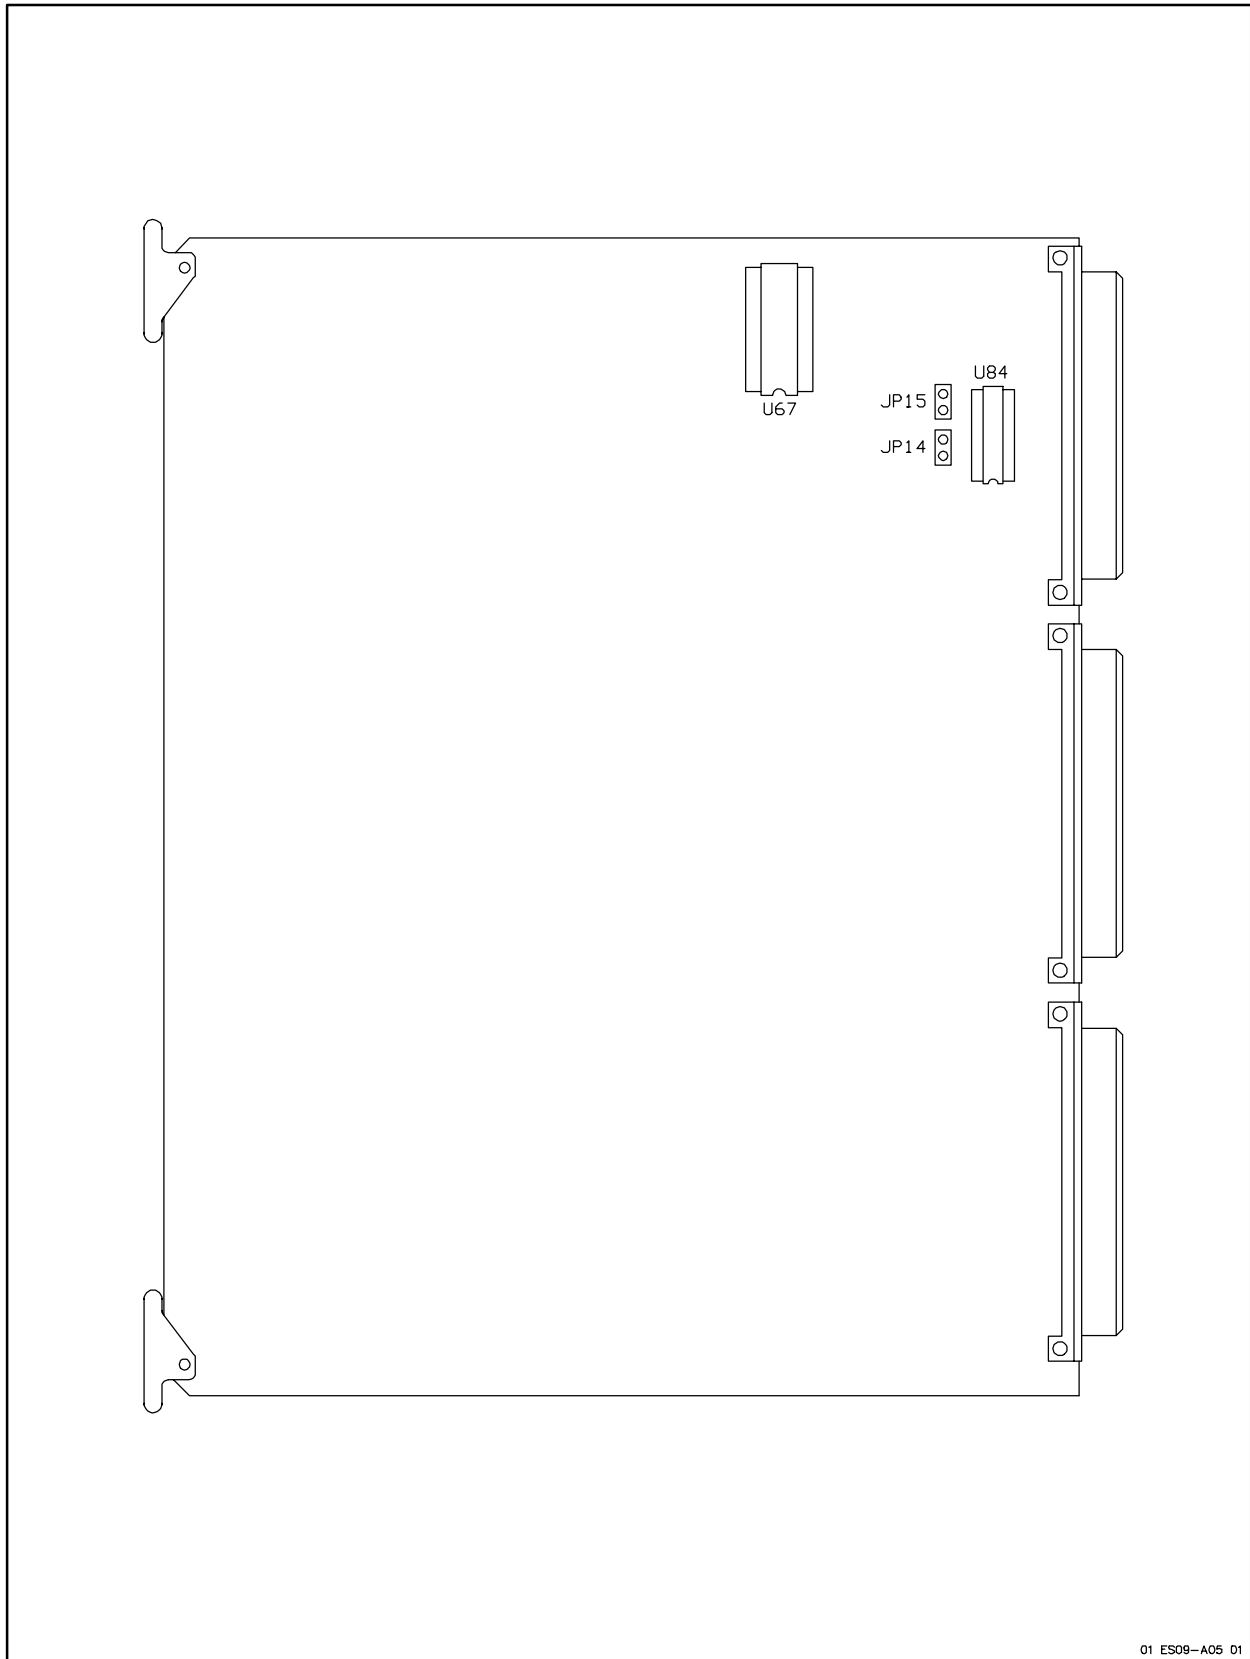
Figure IIIA. 3500-1261/1262-XX PCB

1. Change U84 from a 74F14 to the Oscillator, 3401-0027.
2. Remove the jumper from JP15 and install it at JPI4.
3. Using the label 4100-0092 or any small blank stick-on label, re-mark the PCB as a 3500-1262-XX.

COMMENTS: This change renders the PCB as a Non-Doppler Sync when it was a Doppler sync before.

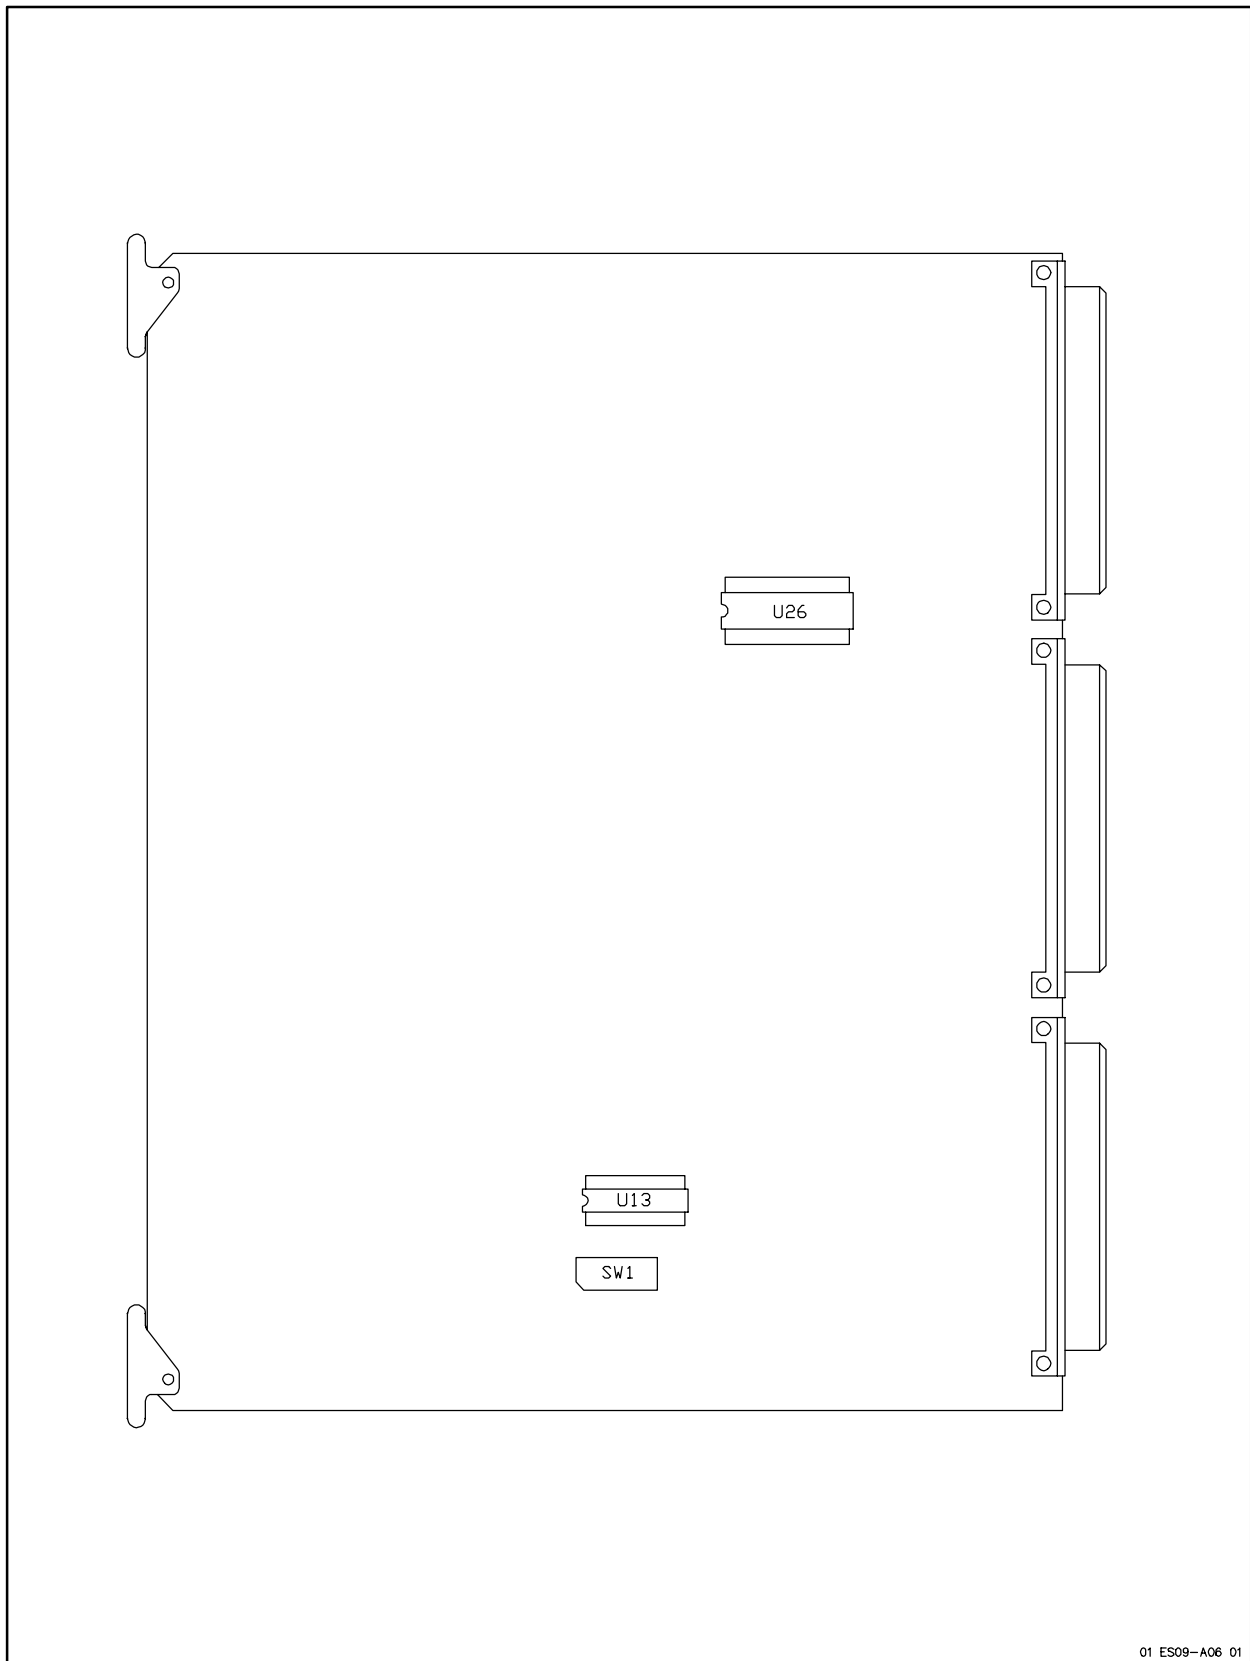
Figure IV. 7500-0374-XX PCB

1. Remove IC from U13 socket (See [Figure IV](#)).
2. Install 4201-0282 into U13 socket.
3. Make sure all switches on SW1 are "ON. "
4. Using 4100-0092 label or any available small blank stick-on label, mark the board as -01.

COMMENTS: This change renders the PCB compatible with software at a lower Rev than 12X.

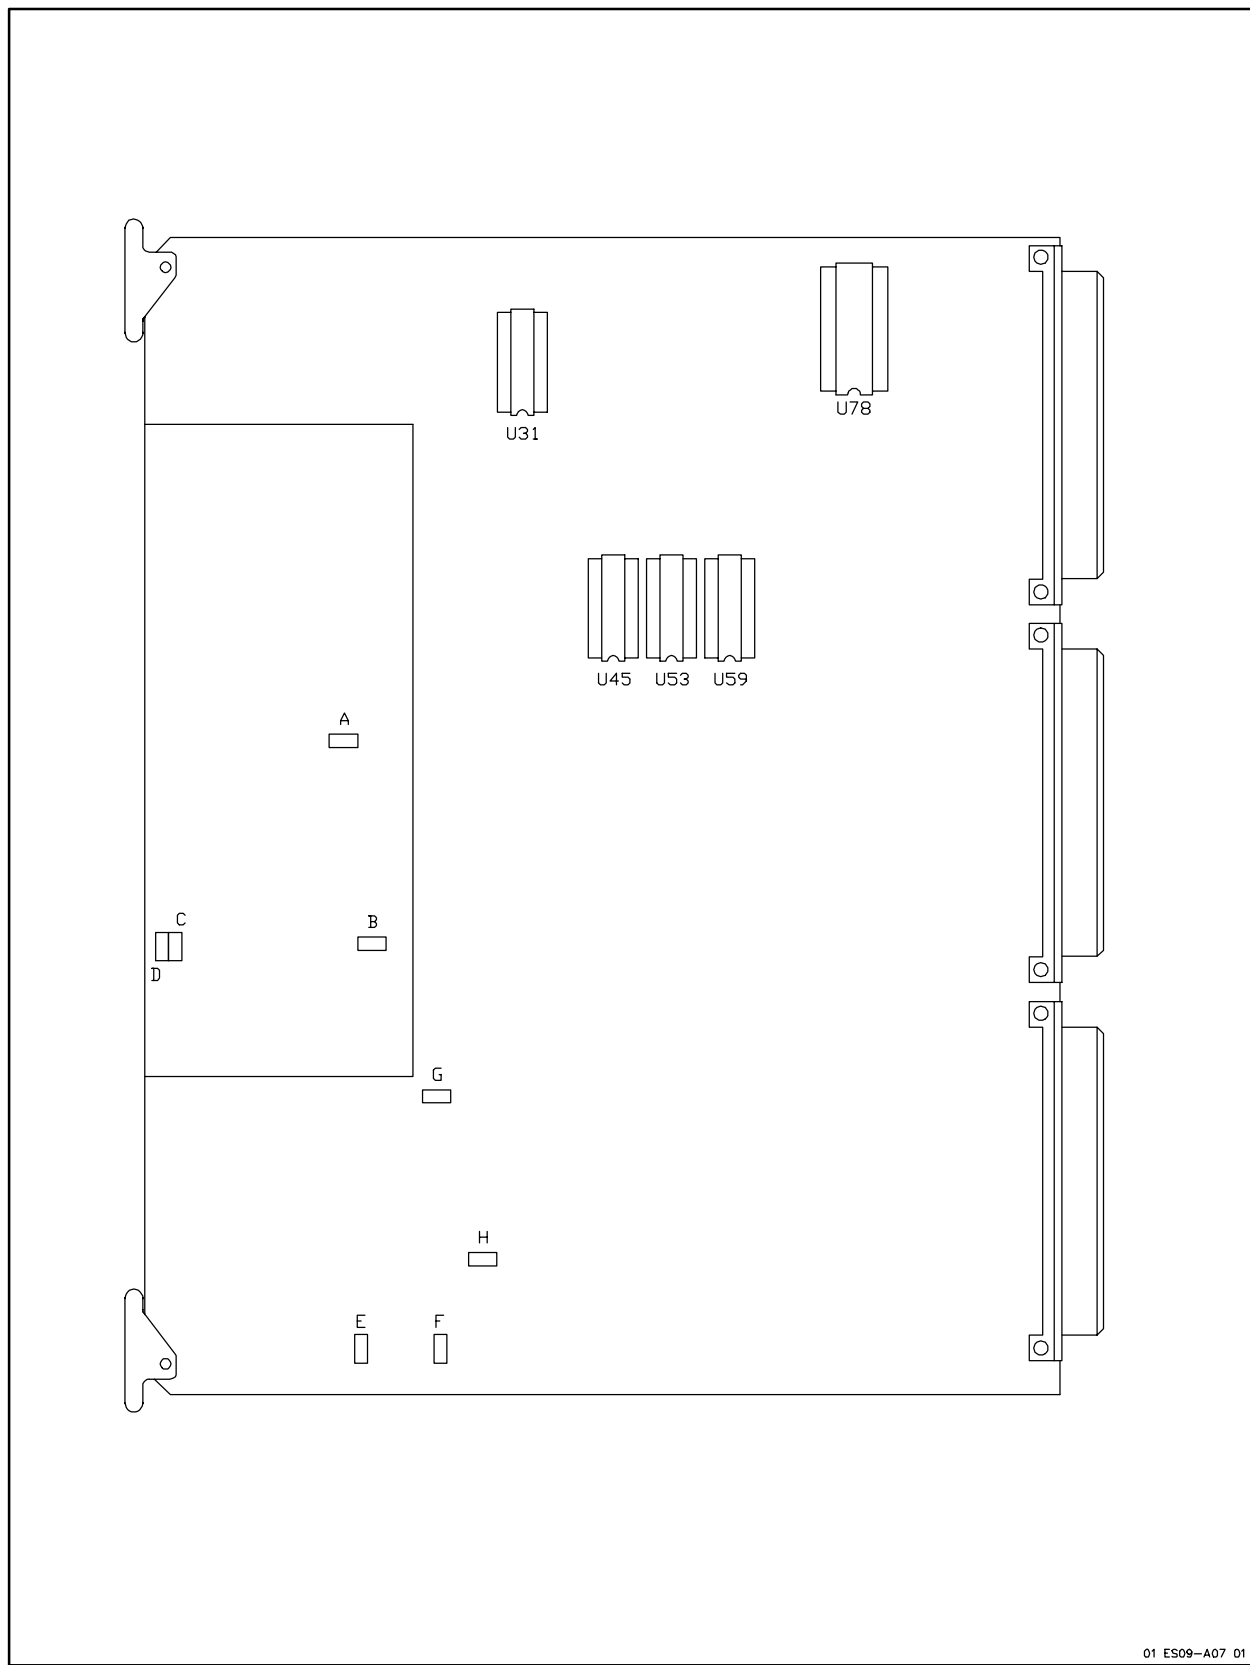
**Figure V. 7500-0313-XX PCB**

1. Remove IC from U78 socket (See [Figure V](#))
2. Install 4201-0214-01 into U78 socket.
3. Make sure all switches on SW1 are "ON."
4. Using 4100-0092 label or any available small blank stick-on label, mark the board as -02.

COMMENTS: This change renders the PCB compatible with 4X, 5X, 6X software.
